Stennis Space Center (SSC) B-1 Test Facility Liquid Hydrogen Run Tank Vacuum Anomaly & Repair

Nicholas J. Nugent

April 10, 2012

Engineering & Test Directorate
NASA, Stennis Space Center

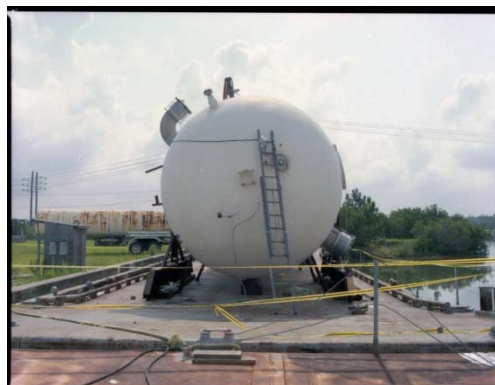
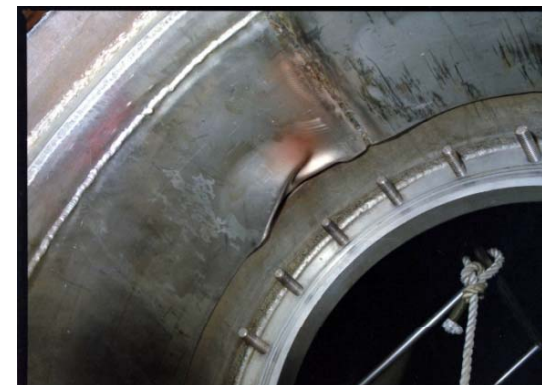
1985 Damage to Manway Liner

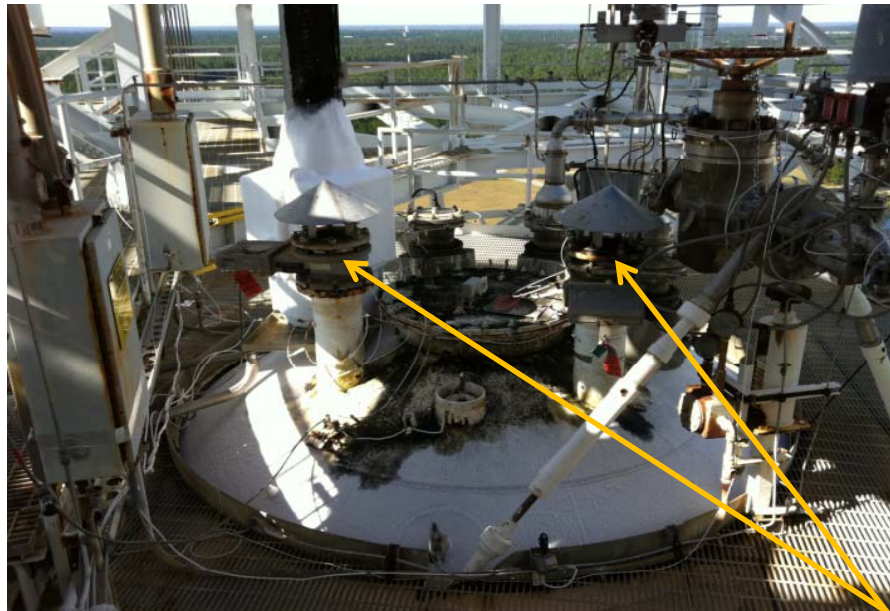
LH Run Tank (top)

- Vacuum issue found
 - Top of the tank – high (>20,000 microns)
 - Bottom of the tank – nominal (<10 microns)
 - Liquid level ~50%
- Cracks discovered in the two rupture disc holders located on top of the vessel

Rupture Discs
& Holders

- The cracks allowed an unknown amount of air to enter the annulus.
- The air then froze to the inner vessel outer wall.
- The differential vacuum pressure between the top and bottom annulus indicated compacted perlite and/or frozen air in the annulus.
- High top pressure cause still under investigation. Likely the result of crack growth since previous measurement and/or a vacuum pump being switched off/serviced preceding weekly measurement.

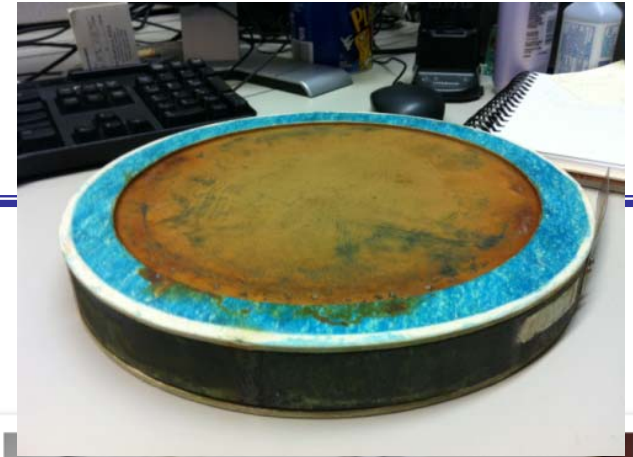
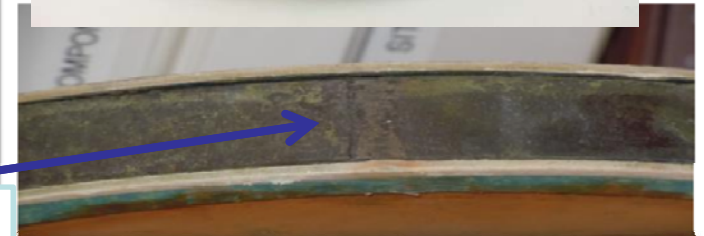
- Rupture disc #1 was identified to be leaking via bagging since cracks not visible when installed
- Rupture disc was removed and found to be cracked
- Rupture disc holder was made of graphite and installed in 2003.
- Companion flange was heavily corroded
 - Wire brushing of flange was unsuccessful
 - Flange was sent to machine shop and faced for improved finishing and sealing
- Companion flange and new rupture disc installed
- 2nd rupture disc also leaking but could not be removed due to leaking isolation valve. Utilized Kenny Seal to stop leak.
- No leakage detected via bagging method

Cracks in
Graphite
Holder

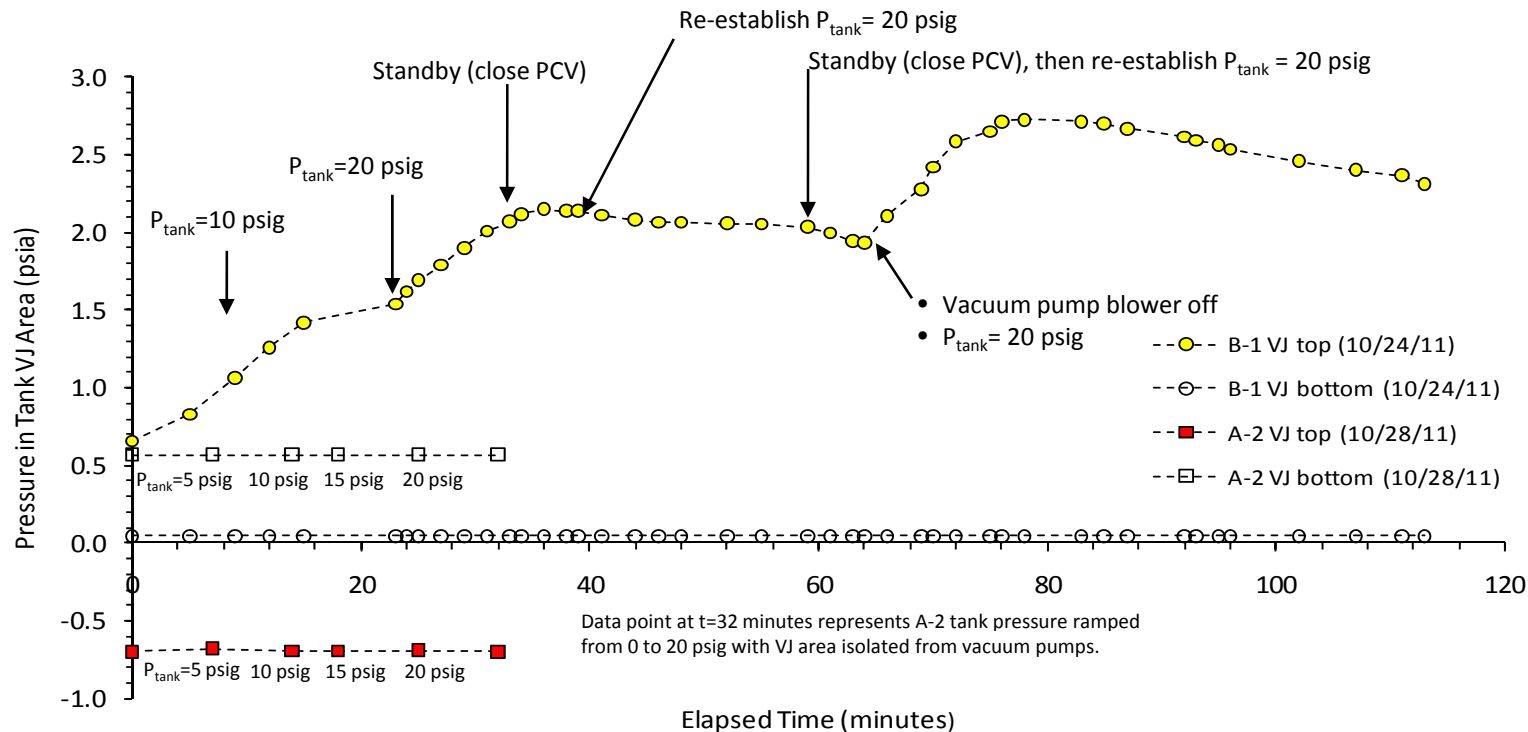
- The pressures in the A-2 LH tank VJ area did not change as the LH run tank was pressurized from 0 to 20 psig
- The A-2 results significantly differ from B-1 adding evidence of a air filled annulus
- Care and precautions must be taken during detanking due to the frozen annulus

- A-2 test completed on 10/28/11 using TPS A2-00891; A-2 LH Tank Level ~ 56% full & B-1 LH Tank Level ~ 44% full.
- Vacuum pump exhaust before and after test contained ~ 10.2% O_2 ; 0% LEL.

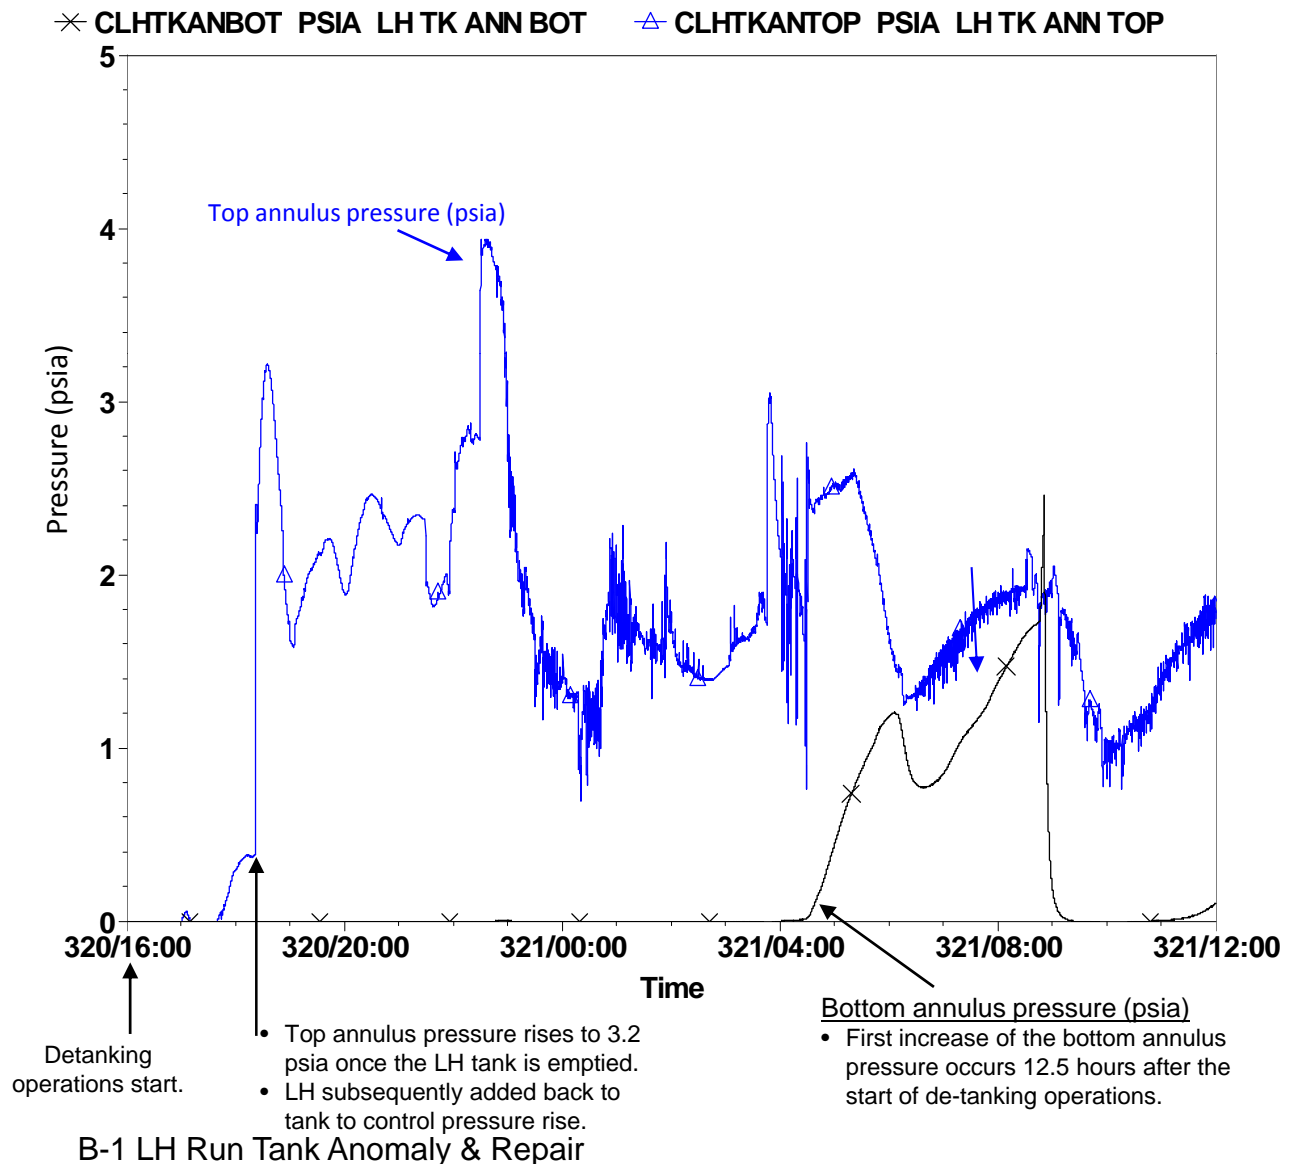
- B-1 LH detanking operations commenced on 11/16/11 (day 320) at 4:00 pm.
- Generally, pressure-vent cycles were performed in addition to emptying the inner tank of LH.
- During the first day of detanking, the top annulus pressure rose sharply to 3.2 psia once the LH tank was empty while the bottom annulus pressure remained at 0 psia.
- The first increase of the bottom annulus pressure occurred on 11/17/11 at 4:30 am, 12.5 hours after the start of de-tanking operations.
- Pressure-vent cycle at 10:45 am (11/17/11) yielded a vent gas temperature of ~140°R.

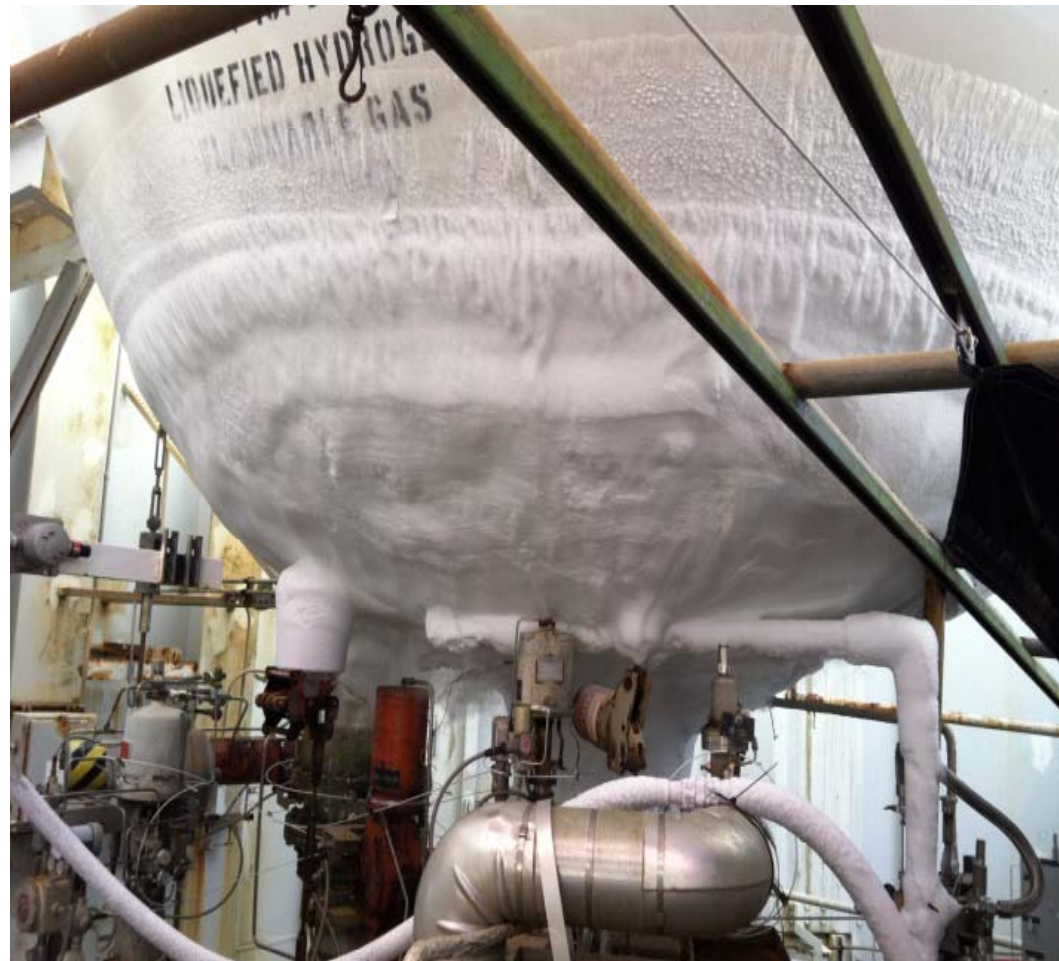
- Two days after detanking heavy ice/frost developed on the bottom of the outer vessel
- The vessel bottom temperature continued to drop into the 140-160 Rankin, consistent with liquid air temperatures
- Well below the 410 Rankin ductility range for the carbon steel material subjecting the outer vessel to cracking at any time

Bottom of LH Run Tank at Low
Temperature

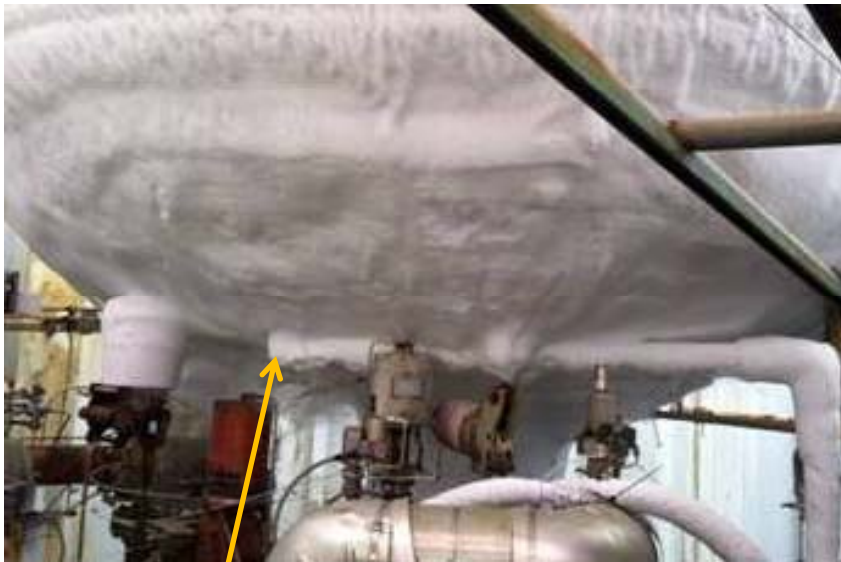
- Attempted to establish pumping ability on bottom annulus
- Utilized existing instrumentation outlet on the bottom of the outer vessel
- Resulted in limited pumping capability due to the small (1/4") available connection size
- AE port
- Upon initiation of pumping vacuum, large amounts of perlite were pumped from the annulus resulting in continuous cleaning of facility vacuum system filters
- "Hot tap" drilling device was designed, fabricated on site, and utilized to drill into the existing bottom vacuum header immediately adjacent to the outer vessel bypassing any clogged external filters

**1/4" Instrumentation Port
used for Vacuum Service**

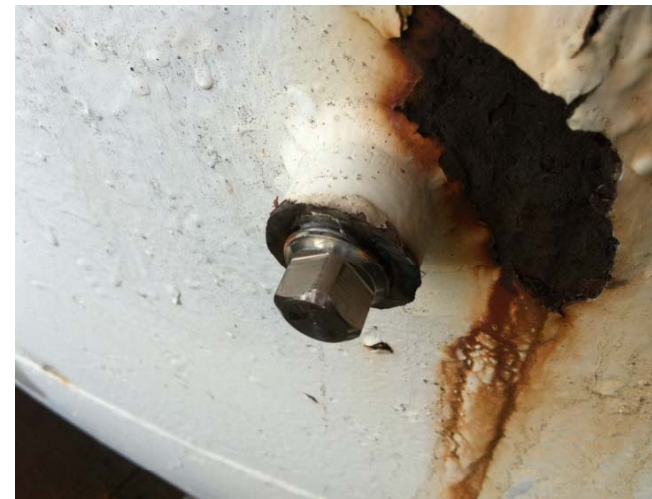
**Plug Removed for Vacuum
Connection to AE port**

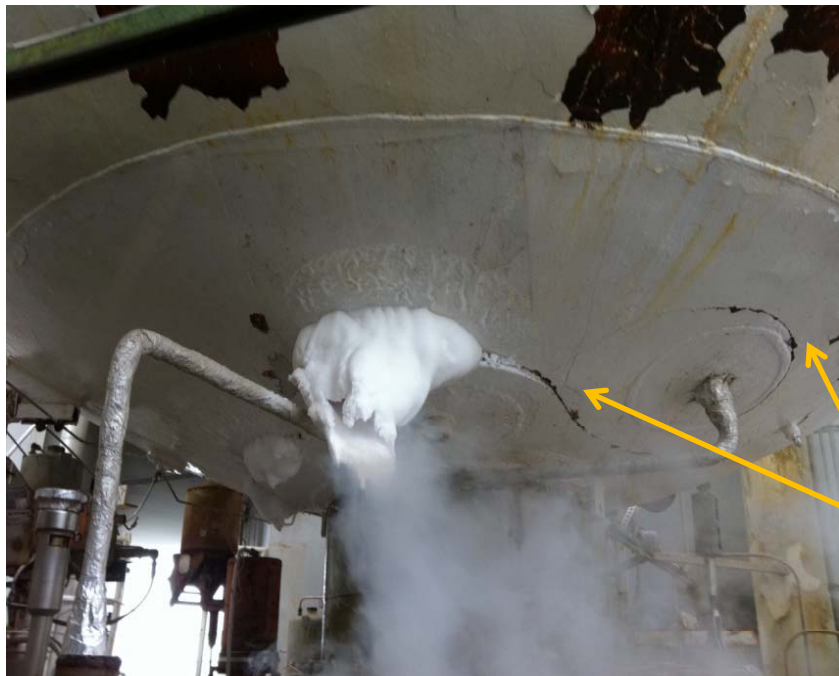
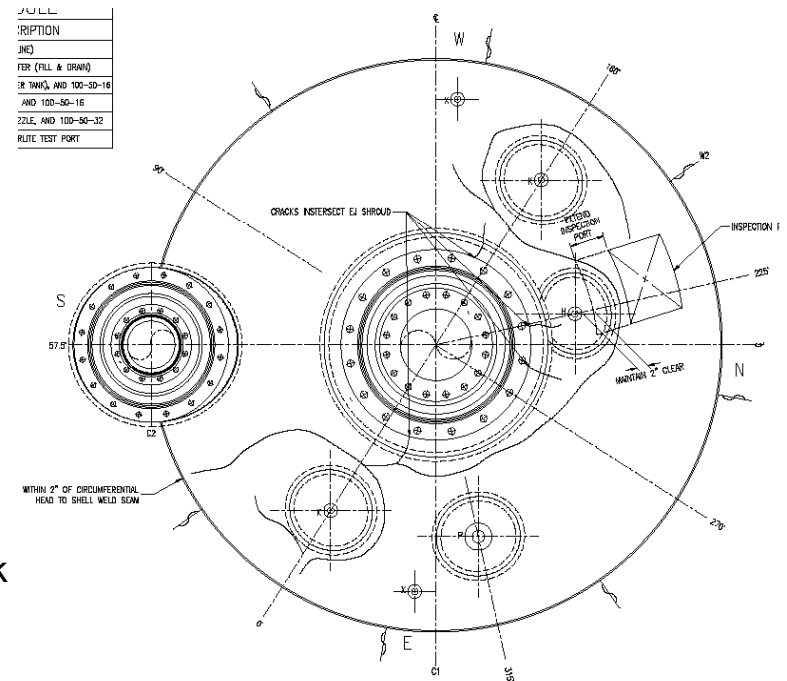
LH Tank Bottom

- At 10:05am on December 4, 2011, during preparation for installation of the external perlite filtering system, an audible “pop” emanating from below the tank was heard by the test crew
- The on stand test crew was evacuated into the protective concrete hard core of the test facility and then evacuated to the test control center through the instrumentation tunnel
- Video and instrumentation data at the test control center showed a release of vapor from the bottom of the vessel through a crack accompanied by an immediate slow rise in the vacuum annulus pressure at the bottom of the vessel.

Crack

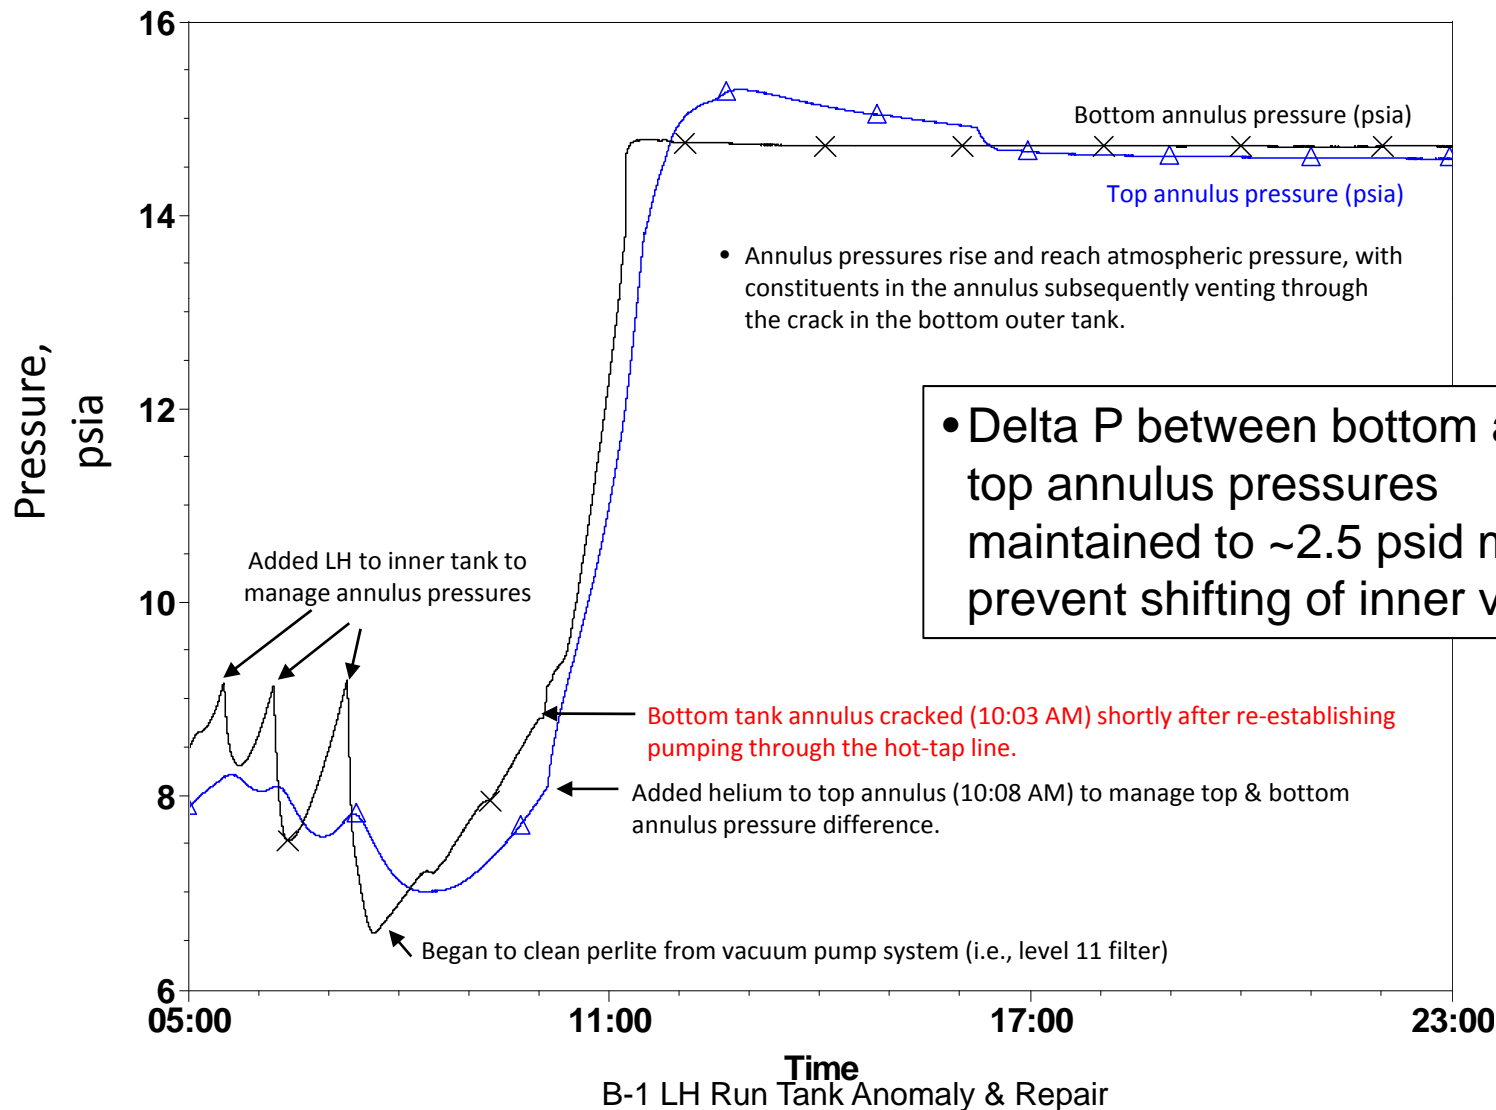
✕ CLHTKANBOT PSIA LH TK ANN BOT
△ CLHTKANTOP PSIA LH TK ANN TOP

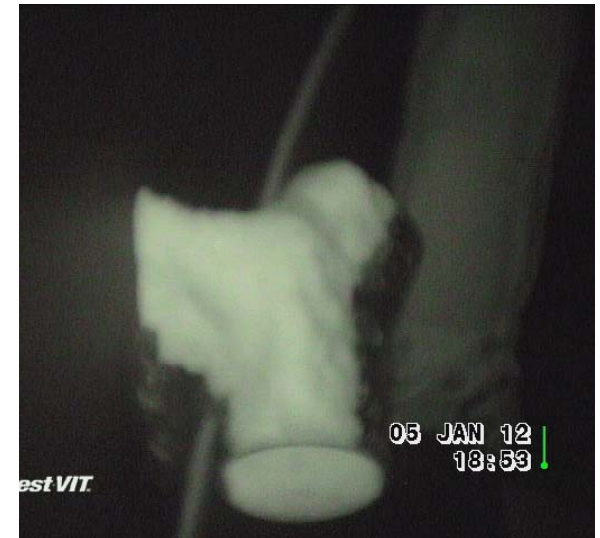
- Lower Vacuum Header
 - Physically disconnected inside annulus
 - Made from flexible hose
 - Lower witch's hat screen plugged
- Previous Issues with Tank at SSFL (prior to 1970)
 - Vacuum issues: 6000 micron minimum
 - Iced over vessel bottom during detanking
 - Cracked bottom head area
- Compacted Perlite
- Full vessel will cryopump annulus and show good vacuum
- Inner Vessel
 - Successful Acoustic Emissions test
 - Successful structural support inspections
- Outer Vessel
 - Numerous cracks identified in smaller lower head
 - No issues found in main lower head

Lower Vacuum Header Disconnected

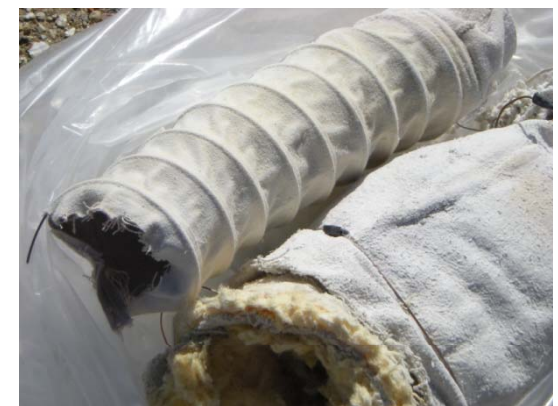
Vacuum Header Flexible Hose

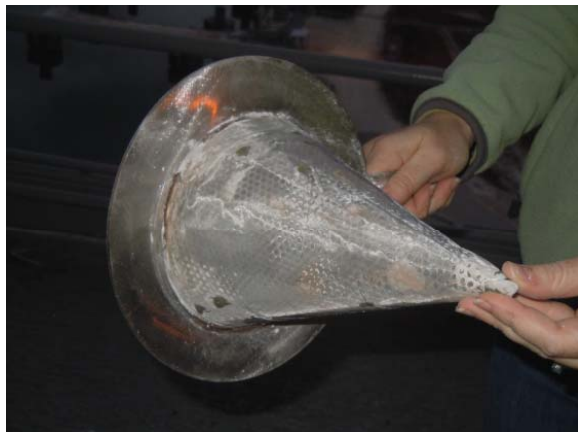
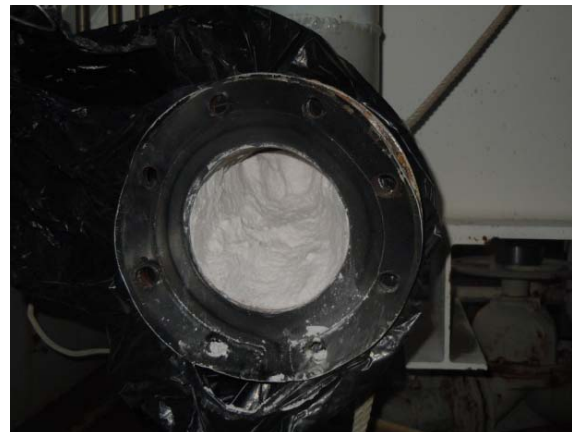
Witch's
Hat
Screen
